Patient Safety Alert

Re: **B Braun - Crimping found in the IV tubing may contribute to false alarms**

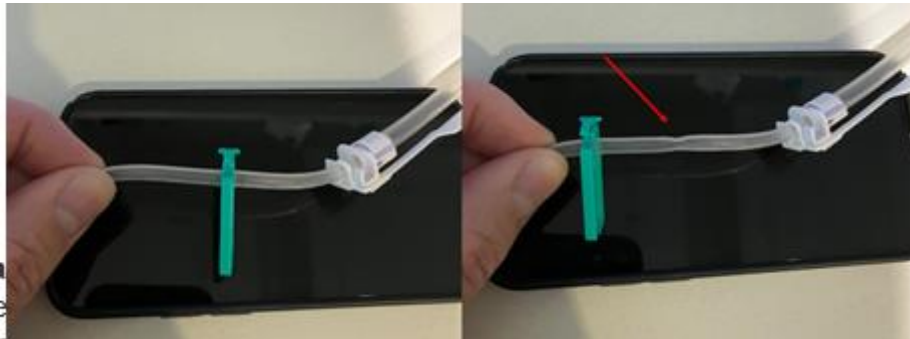
Clamp found partially closed
in the packaging

Crimp identified when clamp
moved to load into the pump

Patient safety is at risk when transfusions are delayed and clinicians are faced with a difficult decision to either discard blood products or to transfuse the remaining products by gravity. Clinicians have observed that some tubing coming out of packaging has crimping in the IV tubing. The pump clamp has been found to be partially closed in the packaging, leaving a crimp that does not return to normal cylindrical shape.

The presence of crimps in the IV tubing section that loads into the pump can lead to an improper fit into the groove where downstream occlusion and air-in-line sensors monitor the IV fluid.

- Assess the IV tubing for crimps in the line upon opening the package
- If crimping is found in the pump sensor zone, attempt to return tubing to normal shape by rolling tubing between fingers
- If this is not successful, and you and your team consider the depth of the crimp to be severe don't use the IV tubing
- Place the IV tubing set that can't be used and its packaging into your unit's identified bin to facilitate follow-up with the supplier
- Alert your site's Supply Chain if your unit is finding that the majority of the IV tubing in your supply room unusable
- Continue to complete safety events/occurrence reporting and vendor product complaint forms for safety events that reach the patient

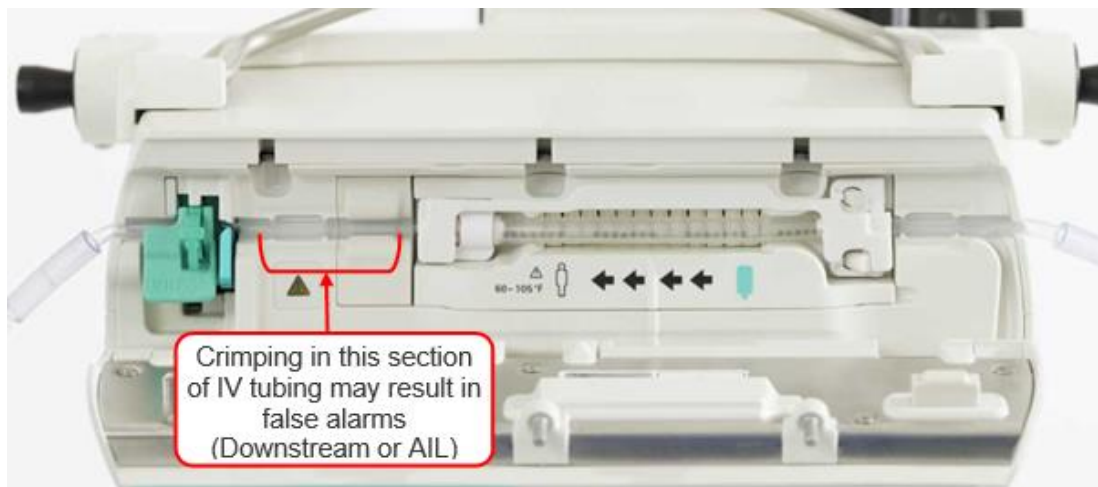
Clinical Engineering has conducted some tests and have demonstrated that crimping of the IV sets interferes with readings from the AIL sensor. Readings from the sensor improve once tubing has been rolled between fingers to improve shape.
