GUIDELINE		SAFE WORK AREA LAYOUT	
Team Name / Team Lead: SCHIPP Team, Regional Director Staff Development, Infection Prevention and Control	Approved By: Vice President – Planning, Innovation, Quality, Patient Safety and Risk	Issue Date: June 29 2016	Review Date: December 20 2017 Revised date: January 2 2018
<p>Potential Hazards:</p> <ol style="list-style-type: none"> 1) If guideline not followed, there is a risk for awkward bending, reaching and over-extension, which can lead to a musculoskeletal injury. 2) Depending on the workload, repetitive motions may be a factor. 3) Client or Caregiver may slip, trip and fall. 4) Client may grab or strike from reactive or defensive behavior. 5) Microorganism Transmission <p>Signs and symptoms of a musculoskeletal injury (MSI) can include pain, burning, swelling, stiffness, numbness/tingling, and/or loss of movement or strength in a body part. Report to supervisor.</p>		<p>Personal protective equipment / devices required / other safety considerations:</p> <ul style="list-style-type: none"> ➤ Assistive devices such as side rail, trapeze bar ➤ Appropriate Footwear for Caregivers ➤ Clothing that allows Caregivers movement ➤ Routine Practices; Add

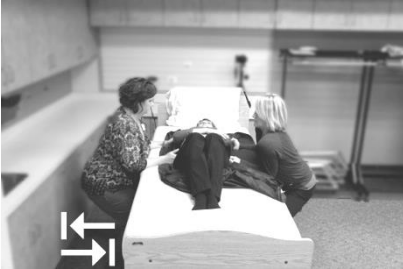
<p>Supportive Information:</p> <ul style="list-style-type: none"> ➤ A safe work area is required to protect Caregivers from ergonomic risk factors, which are commonly present when insufficient space exists for Client handling tasks. These guidelines will help protect Clients and Caregivers from exposure to unsafe work conditions.

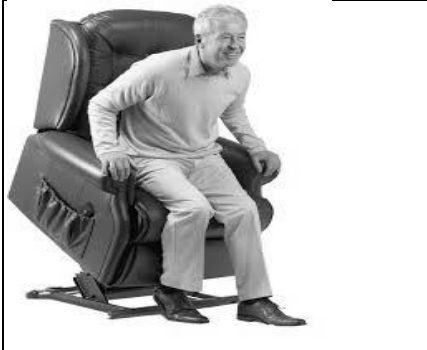
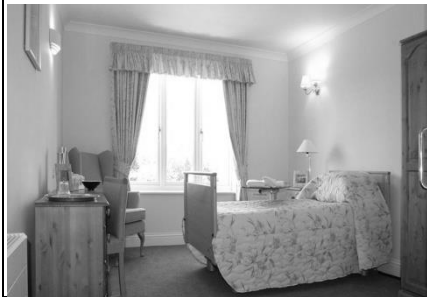
<p>Client Rooms:</p> <ul style="list-style-type: none"> ➤ While it is encouraged that Clients personalize their rooms, there should be clear areas around the perimeter of beds of Clients who require two Caregiver assist with care and positioning. This space should exist so that Caregivers can use safe body mechanics to carry out Client handling techniques and easily maneuver mechanical lifting and standing devices. ➤ Layout of furniture and Client's personal effects is an important consideration to ensure a safe work space. The Care team, Clients and Families should be involved in achieving a safe work area. ➤ Any safe work issues can be referred to the care team and may be forwarded to the local Workplace Safety and Health committee.
