Shared health  
**Soins communs**  
Manitoba

# Standardized Alarm Resolution

## B. Braun Large Volume Infusion Pumps

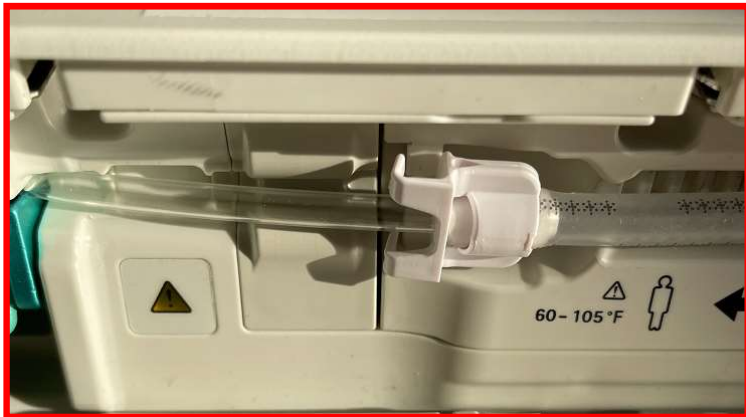
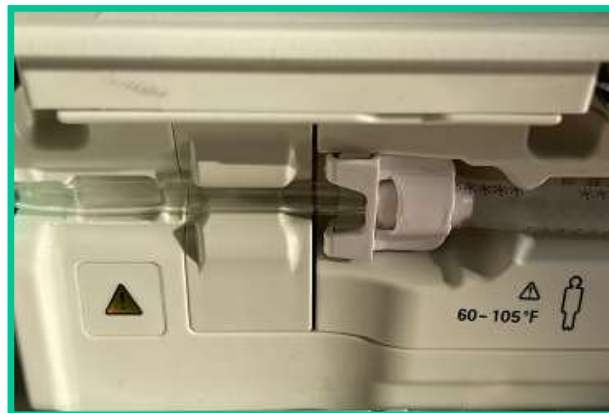
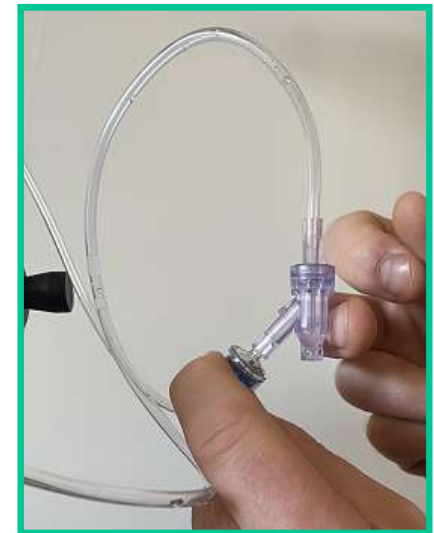
- Bring cold fluids to room temperature prior to administration to avoid outgassing
- Ensure drip chambers are filled  $\frac{1}{2}$  to  $\frac{2}{3}$
- Ensure tubing is properly loaded in the air sensor of the pump
- Prime the IV lines on the pump
- **Invert and tap injection sites during priming**
- **Ensure the ASV is in place at the distal end of the tubing**

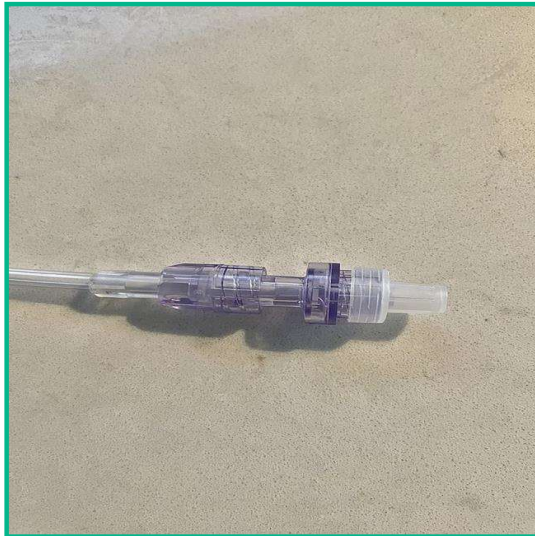
ASV on Tubing

Ensure the ASV is in place at the distal end of the tubing

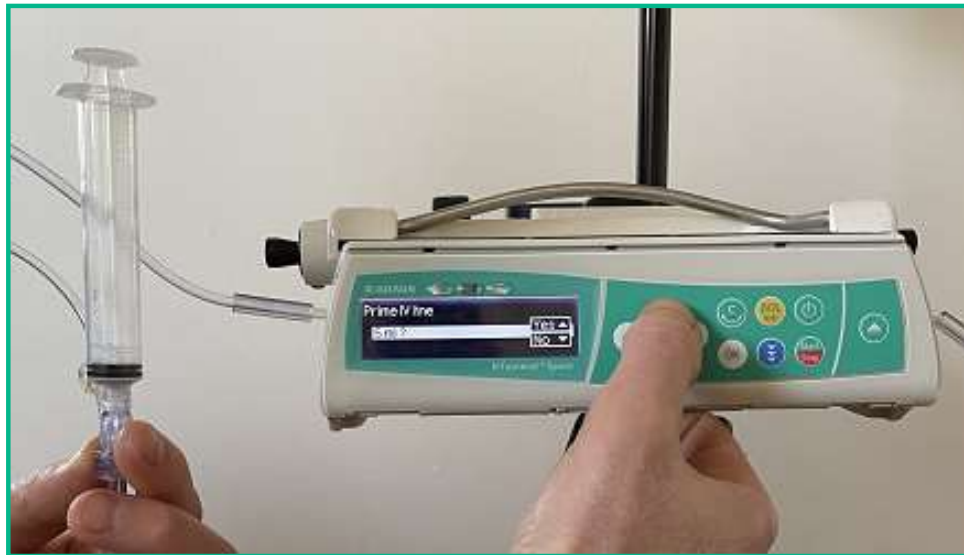
## Step 1

*You will not see the air in the tubing as it is behind the door of the pump*

Use the automatic prime function (1200ml/hr) to remove the air from the line following on screen prompts, then restart the infusion

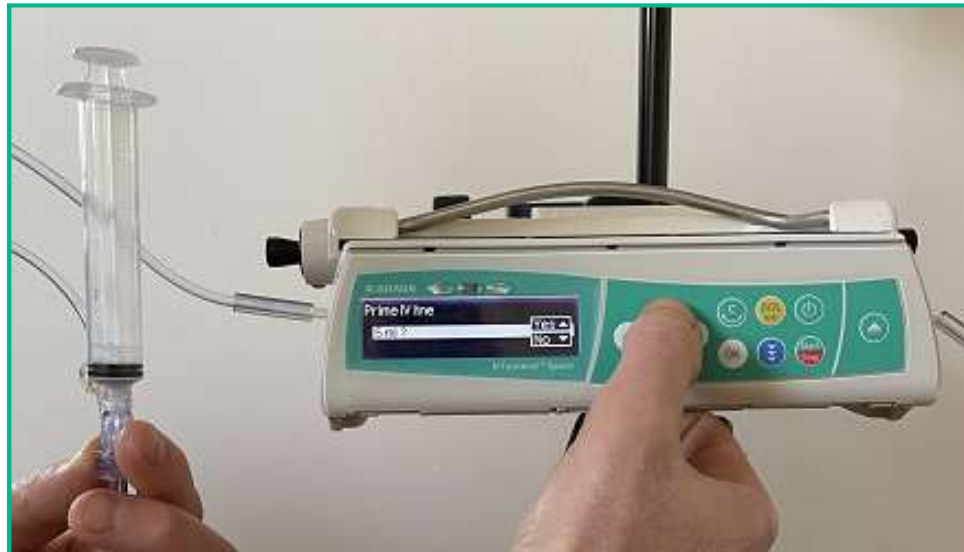
## Step 2

Repeat the automatic prime function to remove the air from the line

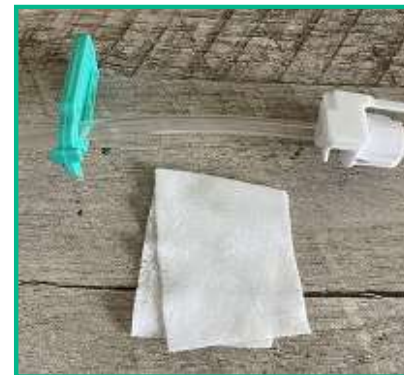
Open the door of the pump, remove, and visualize the tubing, tap the tubing section that is loaded inside the pump and observe for bubbles.

- **If there are bubbles,** remove any visible bubbles as required. Reload the tubing ensuring it is properly loaded within the air sensor, restart the infusion.
- **If there are no visible bubbles,** use a 70% Isopropyl Alcohol pad, wipe the segment of the tubing between the silicone pump segment and the green anti-freeflow protection clamp, reinstall tubing into the pump and restart the infusion.

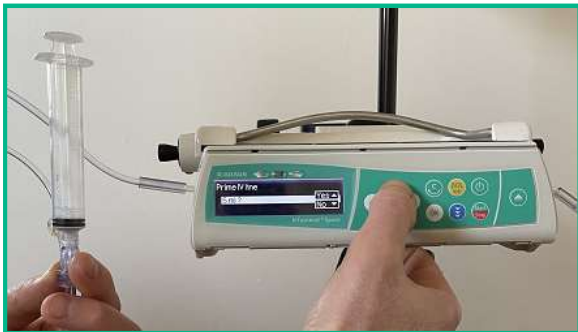
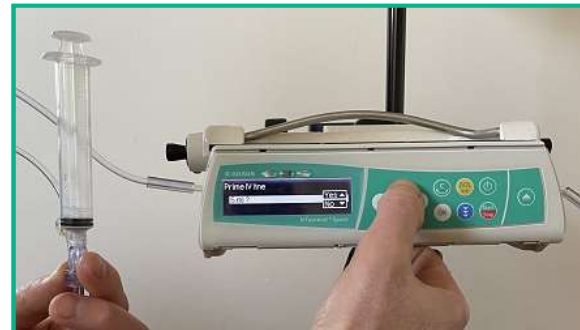
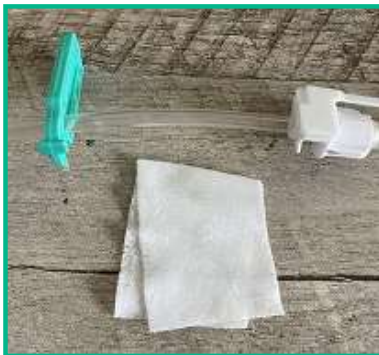
Using new tubing after changing it  
Repeat Steps 1-3

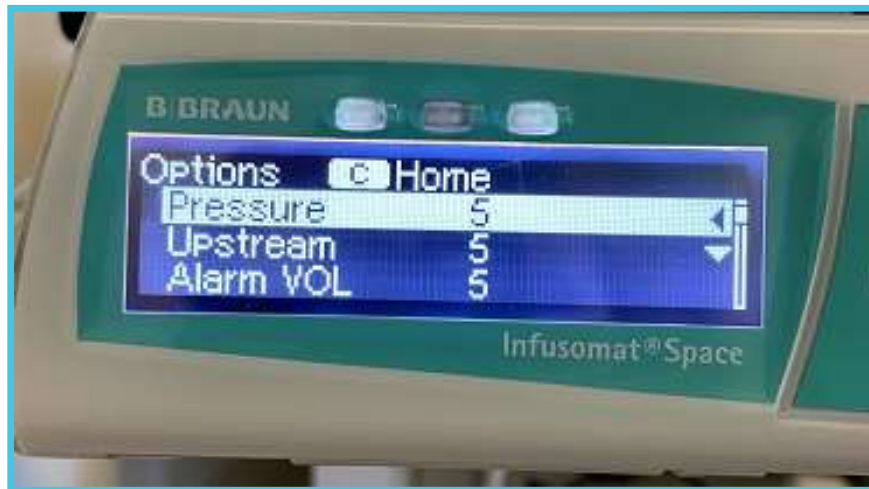
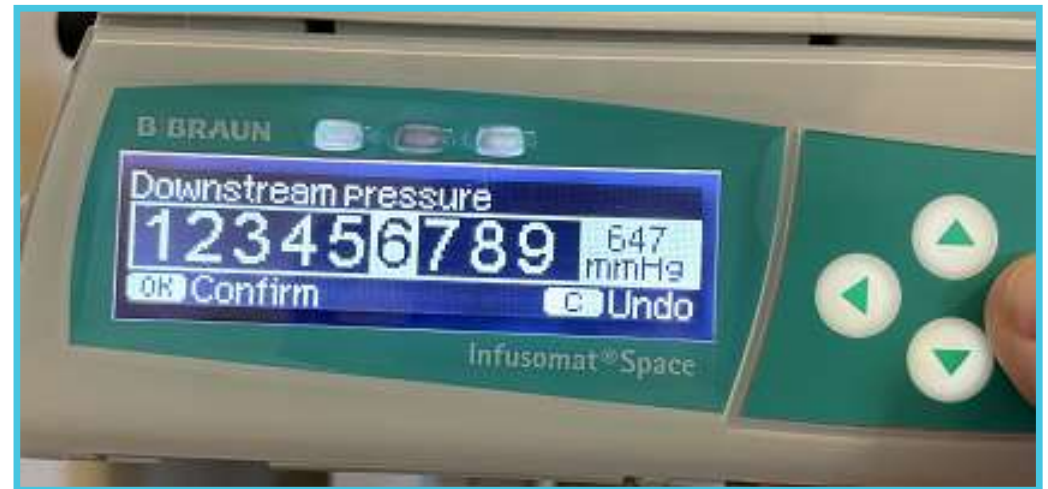
Consider adjusting pressure to alarm limit in options menu.

Increase by 1 increment at a time & reassess resistance after starting infusion

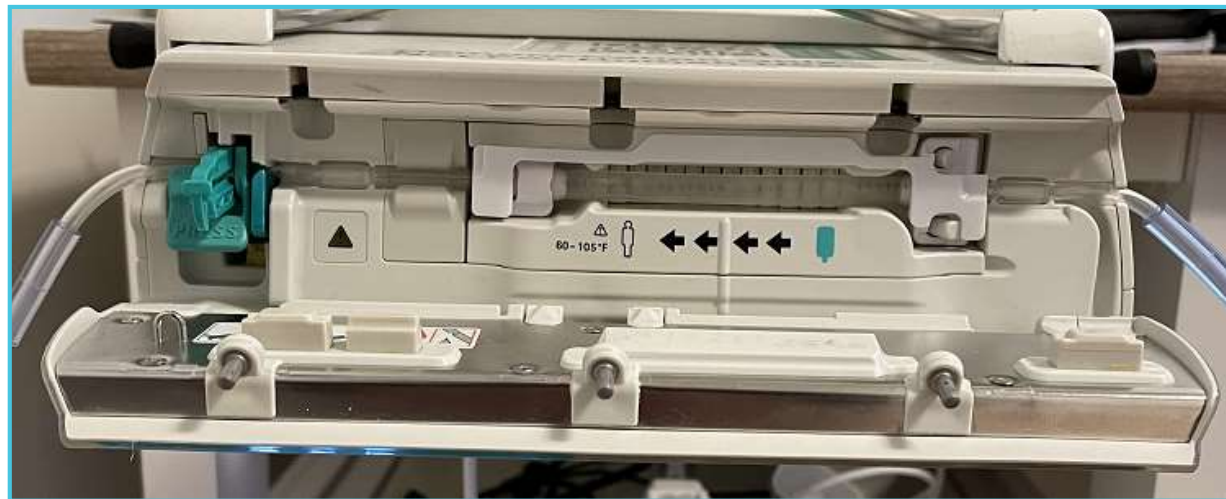
Open door of pump and visualize that the tubing is properly loaded.
